IMPACT OF 1983 STORMS ON THE COASTLINE

Northern Monterey Bay

Santa Cruz County

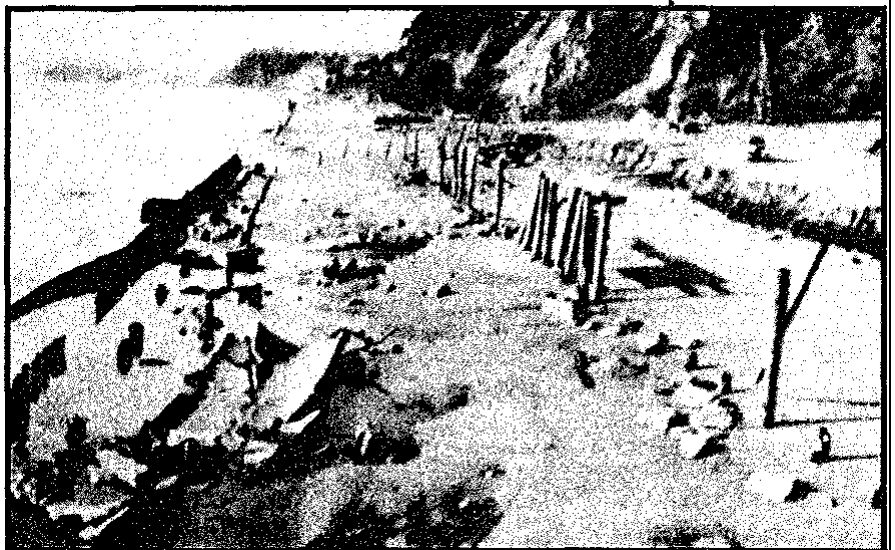
Photo 1. Seacliff State Beach in January 1941. The pilings to the right are the remains of a bulkhead built in 1940 and destroyed during the winter of 1940-41. Structure to the left is the remains of a seawall constructed in 1927 and destroyed the following winter.

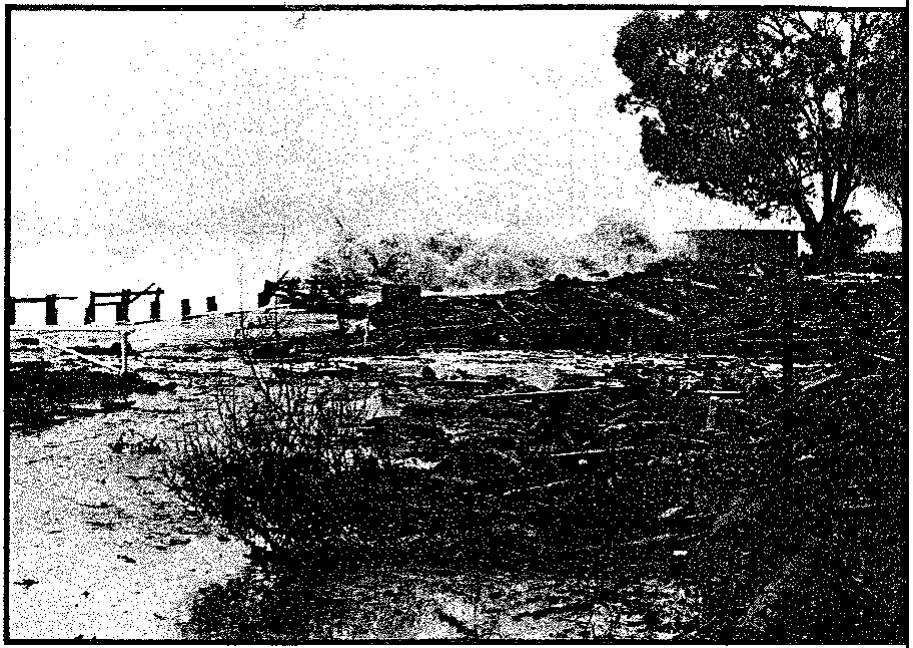
Photo 2. Waves overtopping the seawall at Seacliff State Beach on January 27, 1982, during a 6.6 foot (2 m) tide. The logs and debris on the right have been washed over the seawall and deposited in the camping area.

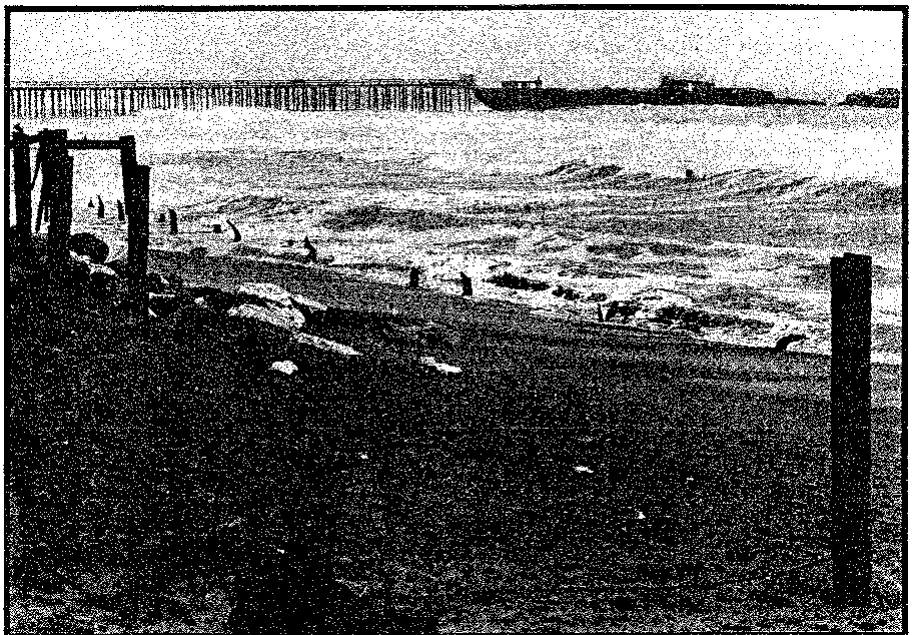
This new structure was intended to last 20 years; in late January 1983, within two months of its completion and dedication, the waves and high tides overtopped the bulkhead (Photo 2). Large logs battered the timbers and pilings and over 214 m of the new structure were destroyed (Photo 3). The parking lot, utilities, and R.V. camping sites were damaged. Logs, sand, and debris were carried over and through the bulkhead to the base of the seacliff. Damage costs have been estimated at \$740,000.

Photo 3. The remains of the Seacliff seawall in March 1983. Approximately 240 meters of a new 800 meter long piling and timber bulkhead were totally destroyed during January 1983 within 2 months of completion.

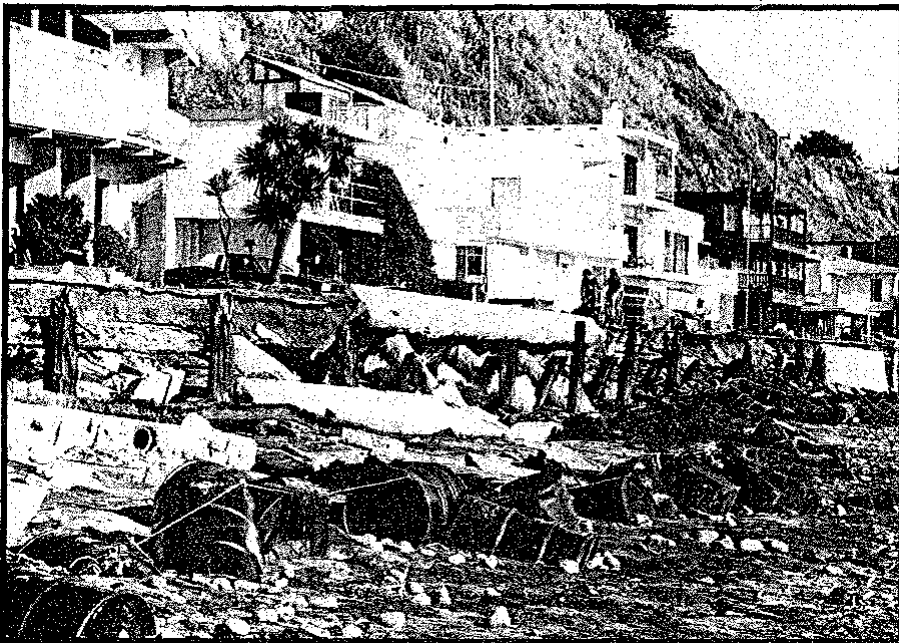
Waves during 1981 storms destroyed a seawall protecting Beach Drive, the sidewalk, one lane of the road, and a portion of a sewer line placed beneath the roadway (Photo 4). During this storm some Beach Drive homes were subjected to broken windows and flooding. An unsuccessful

Photo 4. Storm damage during 1978 storms along Beach Drive in Rio Del Mar. Note remains of timber bulkhead and collapsed sidewalk. A temporary barrier of cabled oil drums failed almost immediately.

ful attempt to halt further erosion by utilizing 50 gallon steel drums was followed by the emplacement of temporary rip-rap. Following this effort, a joint private/state/federally funded \$1.5 million seawall was erected along the central portion of Beach Drive. This structure consists of steel I beams used as pilings, with

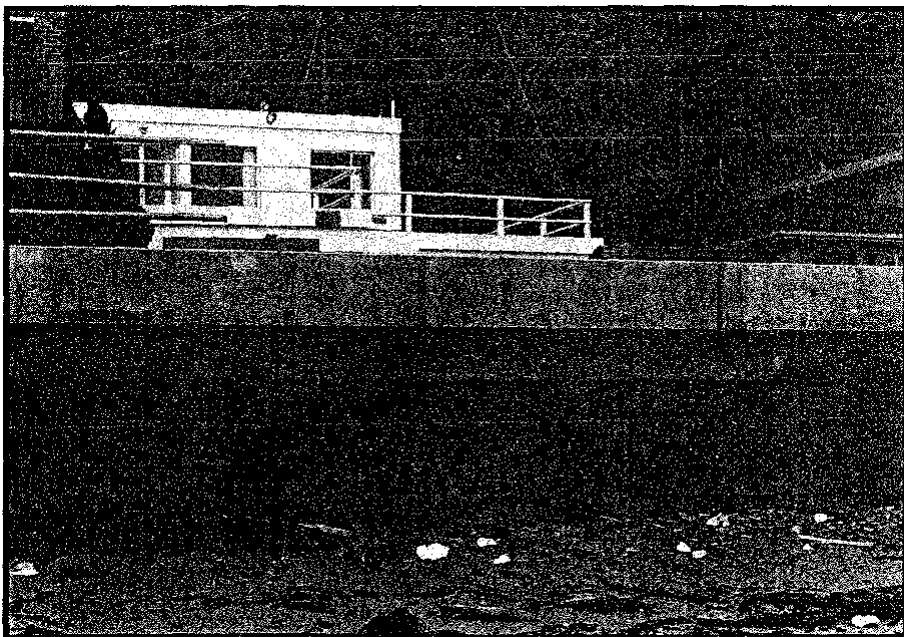
heavy timbers forming the wall, which is capped with concrete (Photo 5). Although the wall was overtopped during the January 1983 storms, and water and sand washed across Beach Drive and into some homes, overall damage to the structure and homes behind the structure was relatively minor.

Photo 5. New seawall along Beach Drive (approximately same location as Photo 4). This \$1.5 million structure was completed in 1982 and consists of steel H beams with connecting timbers and a concrete cap. Although the wall was overtopped and railings were broken off in places, the structure survived the 1983 storms with no damage.

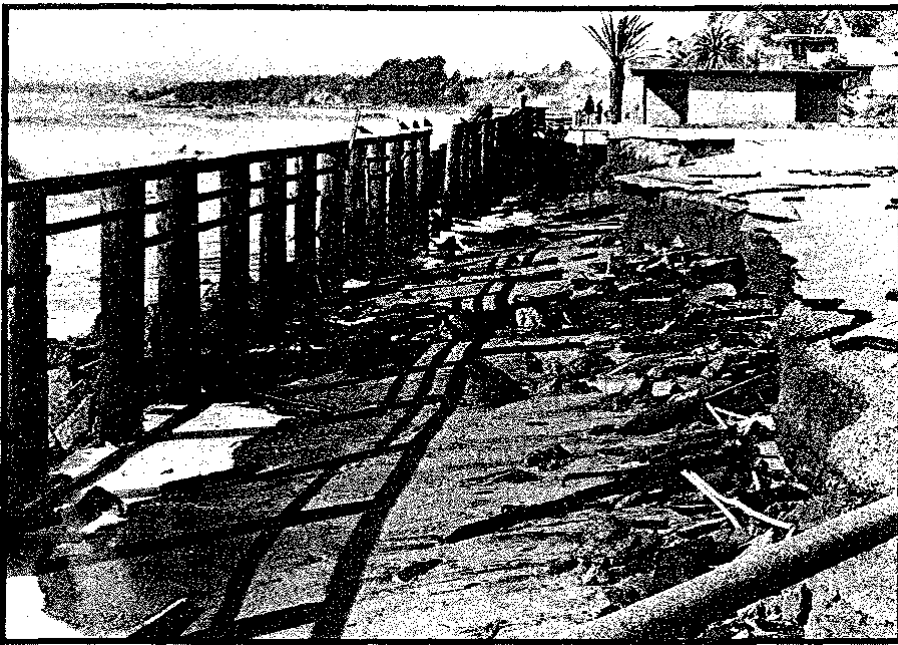
At the south end of Beach Drive, beyond the new seawall, damage was severe. A state beach parking lot was heavily damaged because a timber and piling bulkhead identical to that at Sealiff was destroyed. Waves and logs overtopped the structure, battered the timbers loose, and undermined the asphalt which subsequently collapsed (Photo 6).

Photo 6. Timber bulkhead along Beach Drive parking lot destroyed during January 1983 storms.

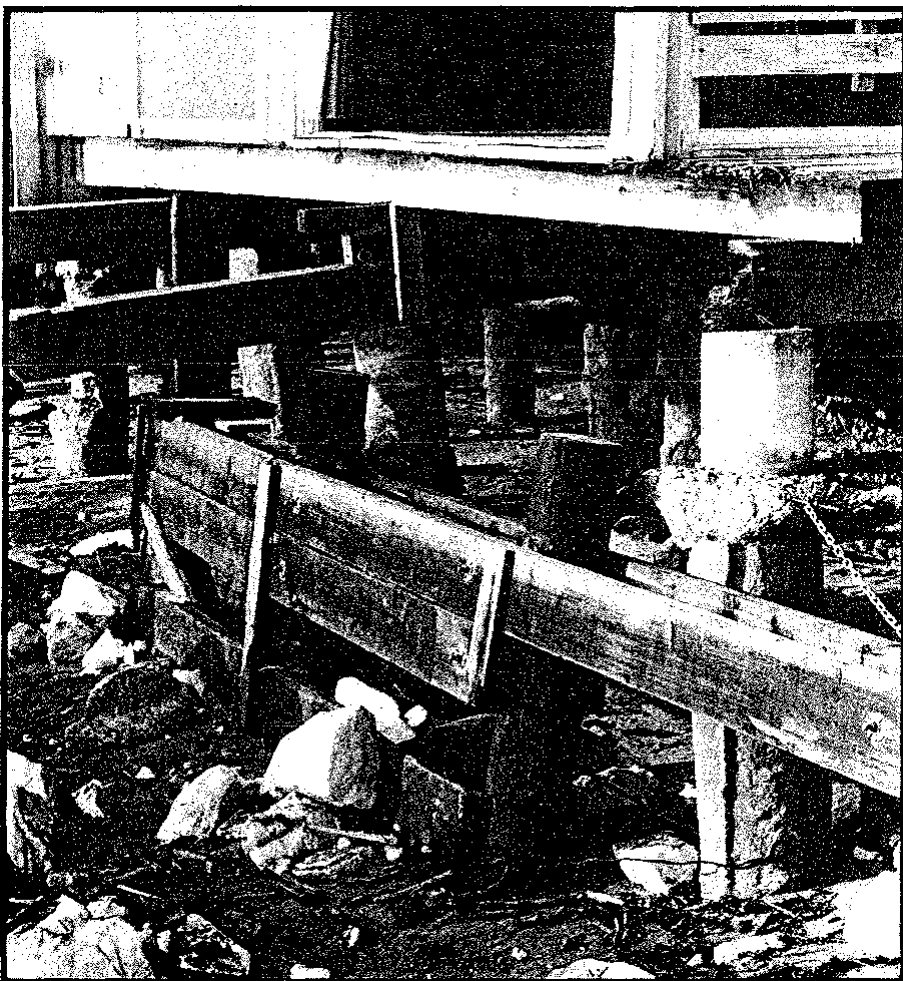
Photo 7. Foundation undermining and seawall collapse at the south end of Beach Drive in Rio Del Mar.

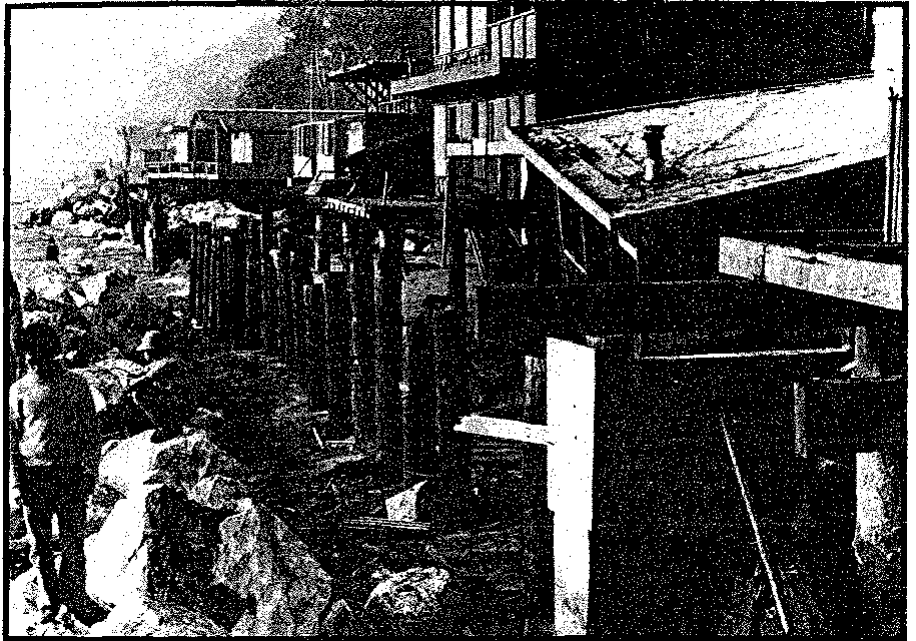
Photo 8. Bulkhead failure and house collapse from undermining of shallow piers along Beach Drive. Rock was brought in after January 1983 storm damage.

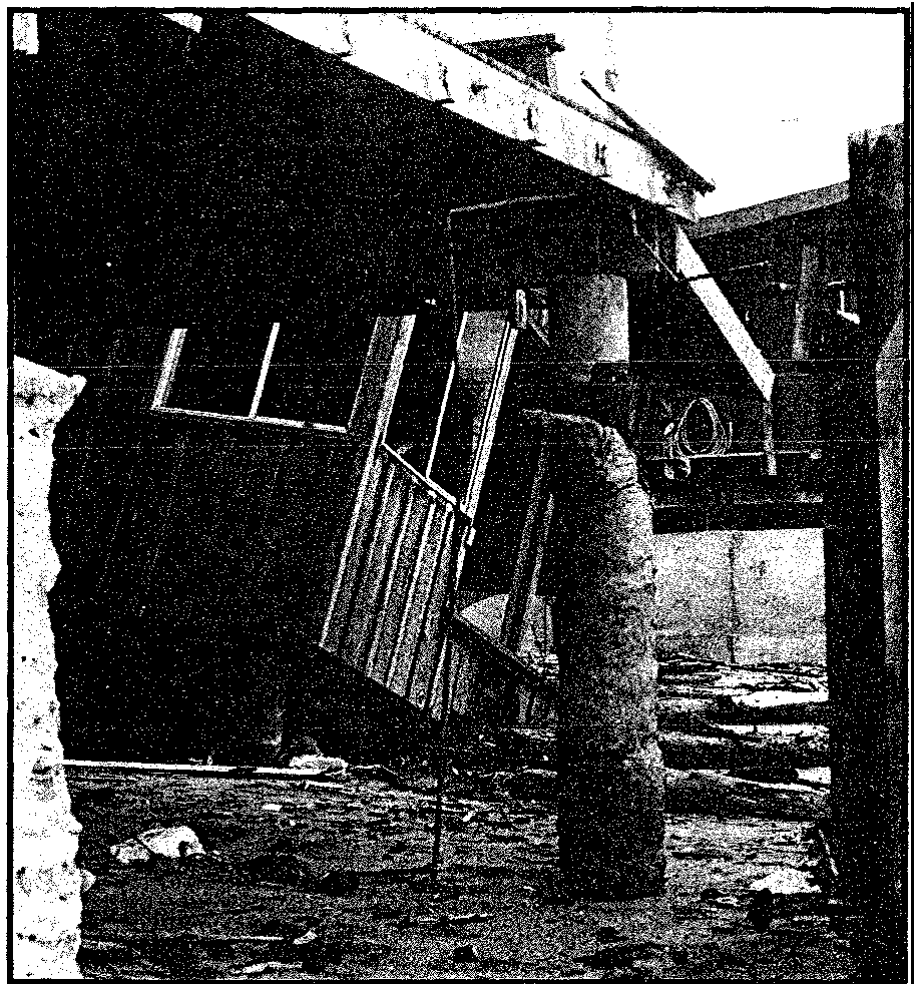
Photo 9. Wave scour during January 1983 storms removed up to 2 meters of sand, leading to failure of shallow piers beneath two houses along Beach Drive followed by collapse.

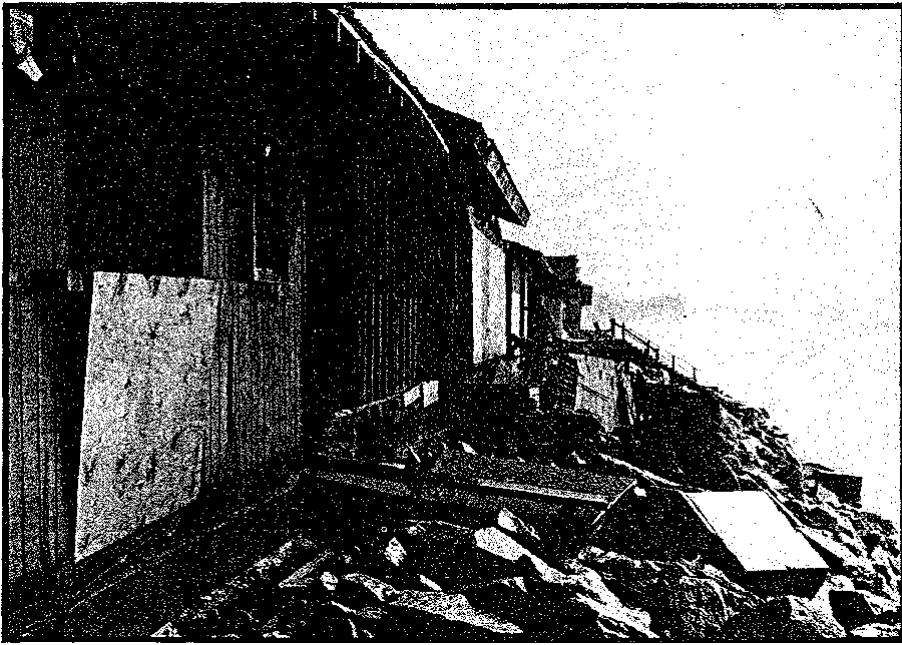
southwest storms in late January 1983, 4-6m waves riding atop tides of 6.6 ft (2m) overtopped the protective rip-rap. Nineteen of 21 homes received major damage (Photo 10). In most cases the waves broke through the windows, doors, and house fronts facing the ocean and washed all the way through the homes (Photo 11). Decks, stairs, and landscaping were also destroyed. One house partially collapsed as the wall facing the sea was demolished (Photo 12). Damage estimates at Seascape range from \$2 to \$2.5 million.

Photo 10. Wave damage to ocean front homes at Aptos Seascape during January 1983. Although these homes were elevated 3-4 meters above the beach and partially protected by a rip-rap seawall, wave overtopping led to damage to 19 of the 21 homes.

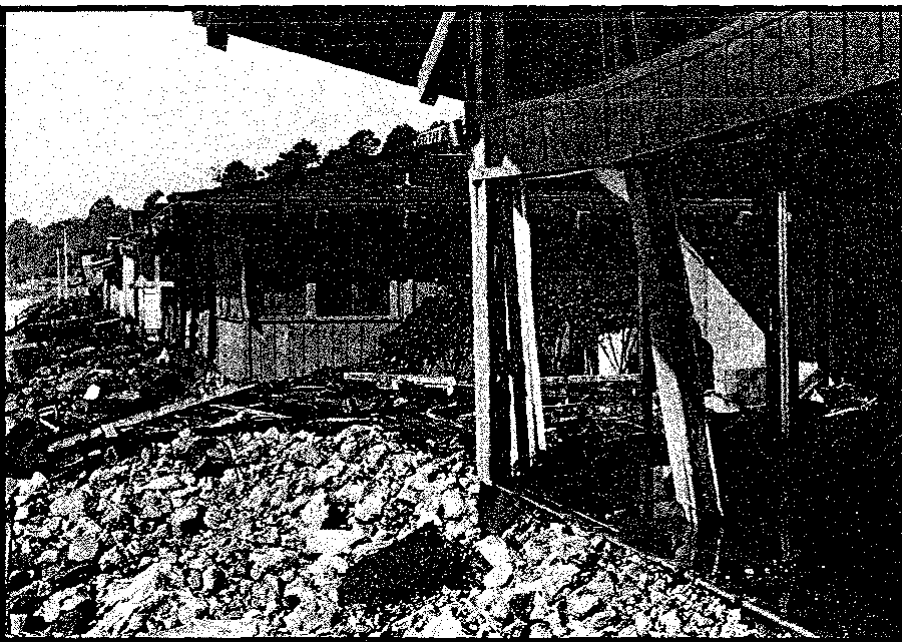
Photo 11. Wave damage to house fronts at Aptos Seascape. Waves created major structural damage by removing supporting posts and walls.

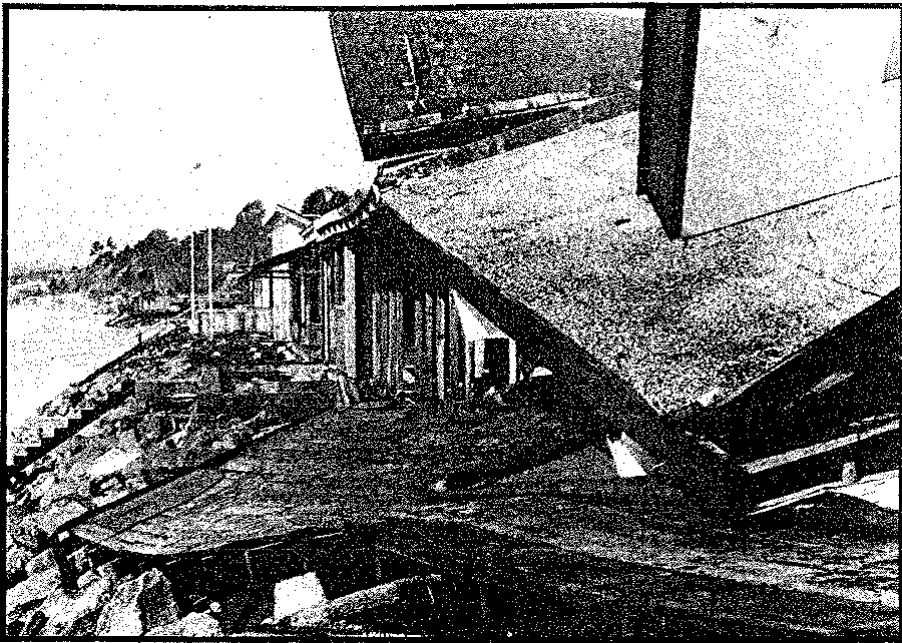
Photo 12. The roof of this ocean front house at Aptos Seascapes collapsed when waves destroyed the front wall in January 1983.

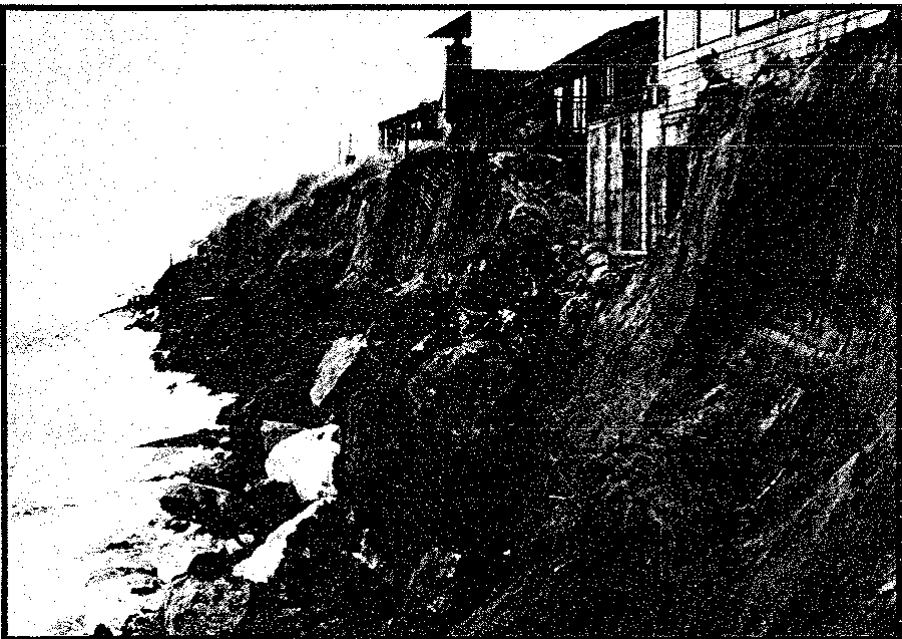
The dunes had not fully recovered due to the severe storms in subsequent years when the January 1983 waves and high tides ensued. Dune retreat took place quickly so that continued wave action threatened at least 17 houses and 25 condominium units (Photos 13 and 14). Rip-

Photo 13. Erosion of dunes at Pajaro Dunes development in January 1983 exposed the foundations and threatened a number of homes. Rip-rap was brought in for emergency repair.

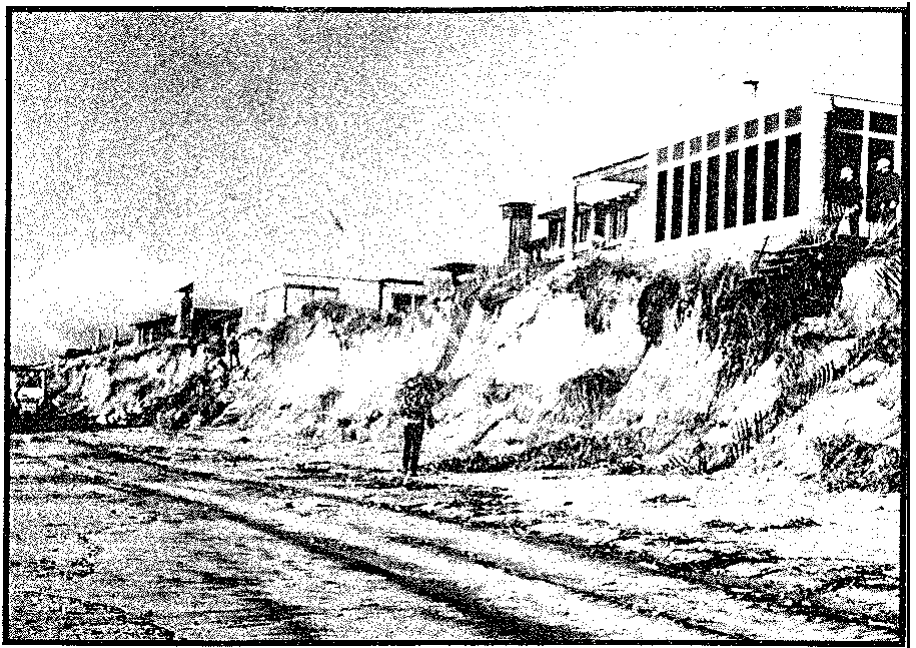
Photo 14. These homes at Pajaro Dunes were constructed atop the first or primary dune. Forty feet of dune retreat occurred almost overnight and waves began to threaten the homes.

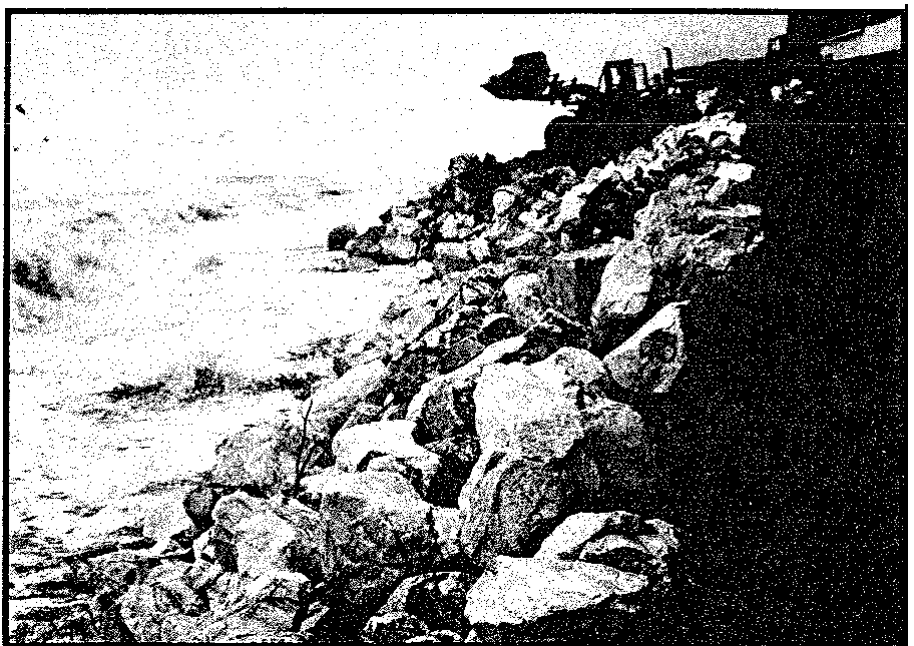
rap was brought in and placed in front of at least 60 houses following the first storm (Photo 15). The initial erosion occurred in late January 1983 when up to 12 m of dune sand was removed leaving a near vertical scarp 4.5 to 5.5 m high adjacent to the foundations of some of the homes. An estimated 200,000 cubic meters of dune sand fronting the Pajaro Dunes de-

Photo 15. Emergency rip-rap was emplaced along almost a mile of ocean front at Pajaro Dunes during January 1983 storms.

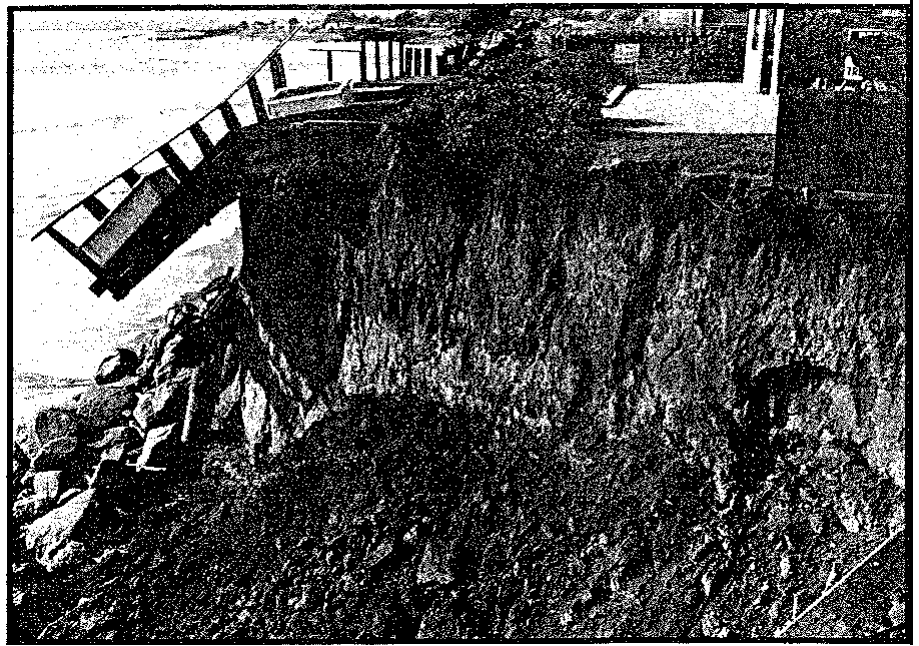
here. Not only is the sea cliff at the foot of the road being cut back at 135 cm/year, but the cliffs on either side are now being eroded laterally, leading to serious private property losses (Photo 16).

Photo 16. Rapid sea cliff retreat at the end of 26th Avenue in the East Cliff area of Santa Cruz. The lack of cliff protection at the end of a public road has led to lateral erosion of private property.

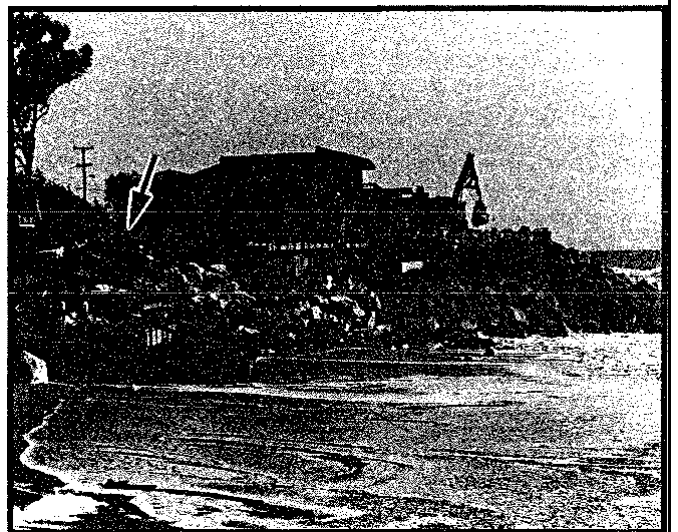
Several kilometers upcoast from Capitola, storm waves on January 29, 1983, completely undercut a beach front house constructed on a concrete slab. The "sea cliff" here is only several feet above sea level. The owners had just moved into the \$350,000 nearly new home 10 days earlier. Within a few minutes on the morning of January 28, the entire slab and two story home tilted towards Monterey Bay as it was undermined. Early the next morning the house slid the rest of the way into the ocean leaving nothing behind but a small pile of wreckage (Photo 18).

Photo 18. The remains of a house along East Cliff Drive (arrow) which was destroyed in January 1983 when its foundation was undermined and it slid into Monterey Bay.

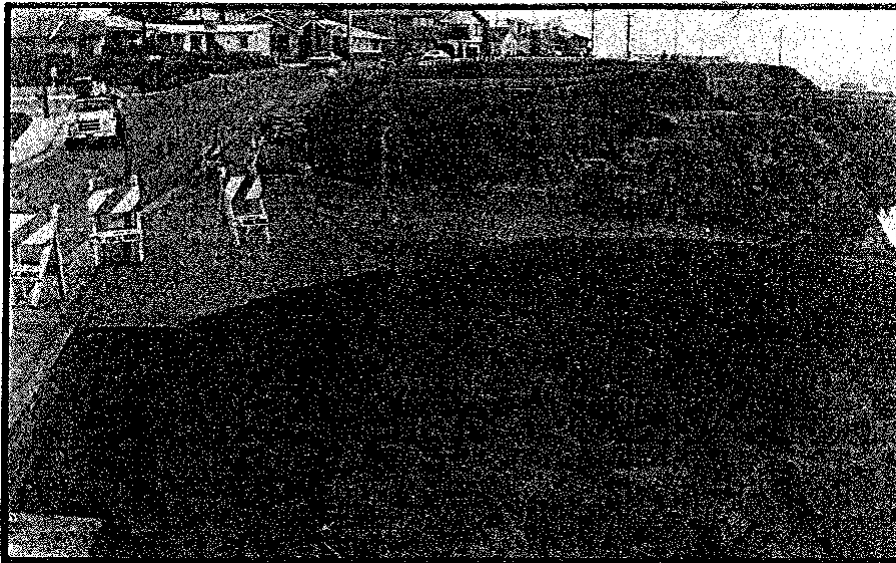
Along West Cliff Drive between Natural Bridges State Beach and Lighthouse Point in the City of Santa Cruz, waves damaged a bicycle path, the roadway, and property of Lighthouse Field State Beach (Photo 19). Again high tides and storm waves simply overtopped the lowest marine terrace and cut back the unconsolidated terrace deposits. Along one particular stretch of West Cliff, 14.1 m of cliff retreat occurred in the first two months of 1983. From 1931 to 1983 a total of 7.7 m of retreat had taken place. "Average" annual cliff erosion for this 51 year period jumped from 15.1 cm to 42 cm when the 1983 cliff failure occurred. The events were similar along much of West Cliff and East Cliff Drive (Photos 20 and 21).

Photo 19. Rapid erosion of unconsolidated terrace deposits took place in January, February, and March 1983 along Wt,st Cliff Drive in Santa Cruz.

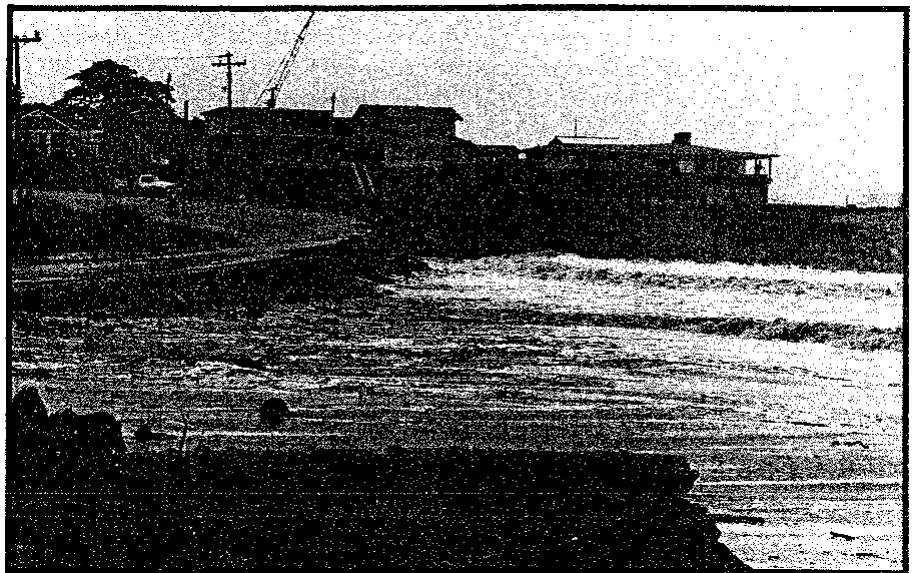
Photo 20. Undercutting of East Cliff Drive just east of the small craft harbor in late January 1983.

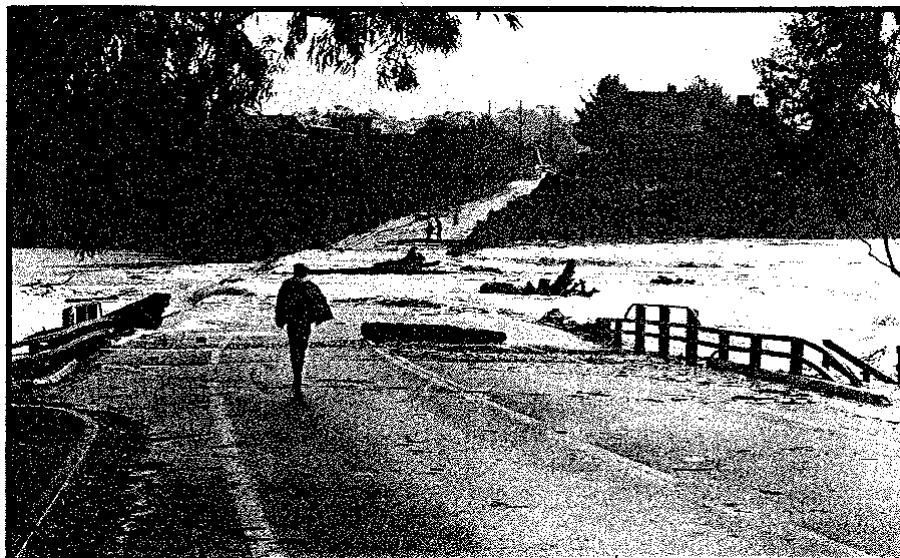
Photo 21. Surf washing over East Cliff Drive between Santa Cruz and Capitola during a 6.6 foot high tide in January 1983. "
