Effects of the Santa Cruz Harbor on Coastal Processes of Northern Monterey Bay, California

G. B. Griggs and
R. E. Johnson

ABSTRACT / An average of 230,000 cubic meters of sand is provided to the beaches of northern Monterey Bay each year by littoral transport from upcoast and from local river input. Two jetties constructed as part of a small craft harbor interrupted the littoral flow of sand and significantly altered the area's natural coastal processes. A wide protective beach immediately formed upcoast against a formerly retreating beach cliff. Sand now filling the harbor mouth each winter has led to expensive yearly dredging as well as seasonally or permanently depleted downcoast beaches. Seacliff retreat, always a problem in the area, is caused primarily by surf attack of weaker stratigraphic units and erosion along joint sets and faults, causing collapse of the bluffs. The seasonal loss of protective beaches has led to a two- to three-fold increase in the rate of downcoast cliff retreat following harbor construction except where protective rip-rap has been emplaced by property owners.

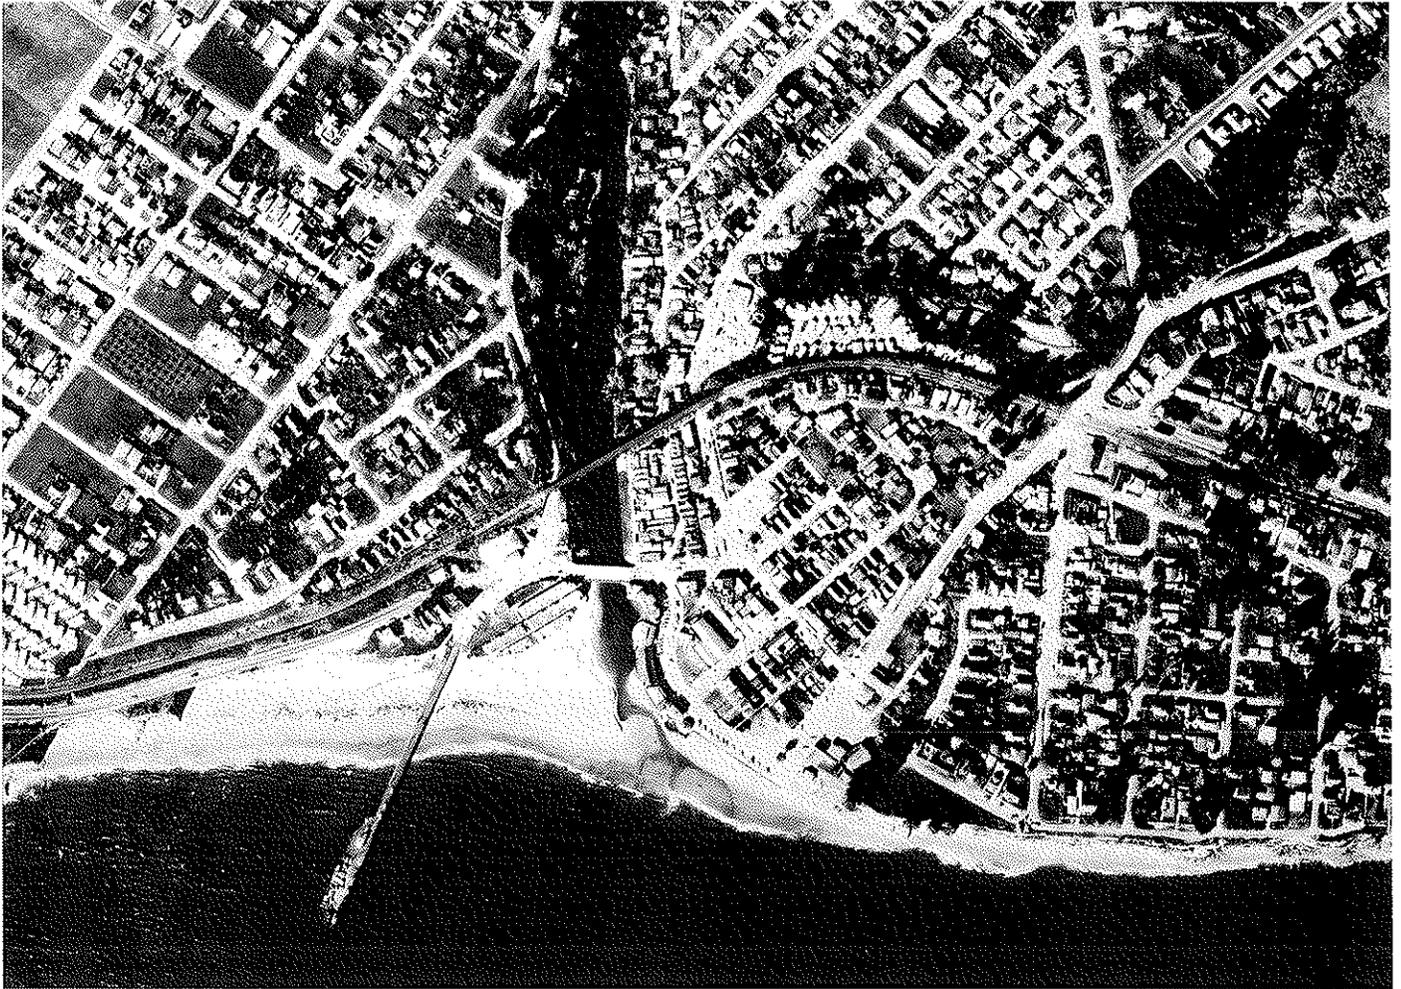
Figure 5. Capitola Beach prior to harbor construction; note width of beach. Photograph taken December 1961.

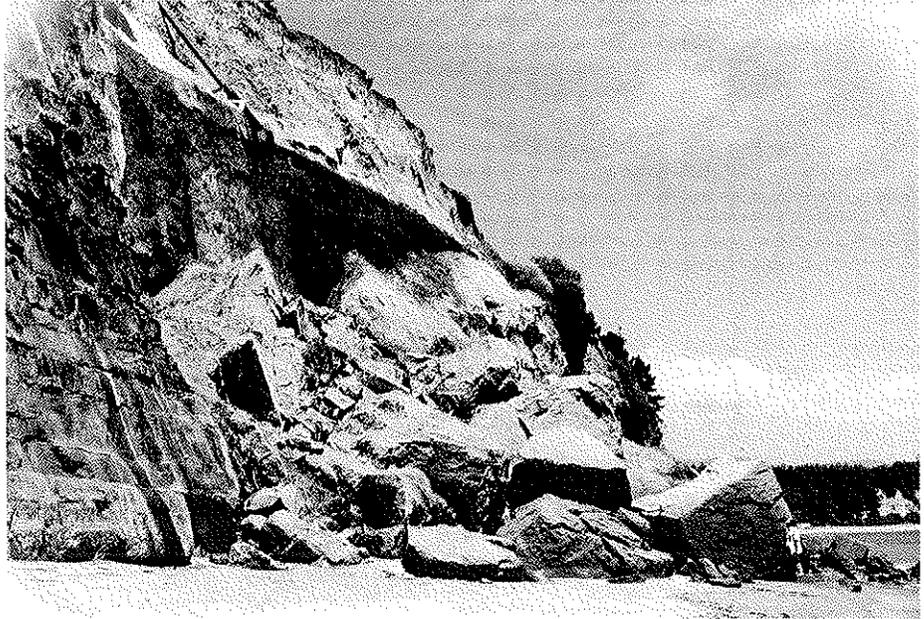
Figure 7.(a) Seacliff consisting of Purisima Formation showing undercutting along non-resistant bed. Note the exposed foundations of the apartments at the top of the cliff. Photograph taken at low tide between Capitola and New Brighton Beach. (b) Photograph taken just to the right of 7(a). Joint sets parallel

and normal to cliff face and undercutting have led to failure of large blocks. Note person in foreground for scale.

Because these master joints are spaced at intervals from 2.5 to 6 m, cliff retreat is predominantly episodic. A given stretch of cliff will remain essentially unchanged for several years and then a section between joint sets will fail instantaneously. Other joints and faults that trend at a high angle to the seacliff are preferentially eroded, forming sea-caves which eventually collapse to form reentrants (Fig. 7a, 7b).
